Manhole Inspection Summary

Manhole # S35KK_039MH

Insp Date: **3/8/07 1:16 PM**

Location Address: **1900 BARCLAY ST**

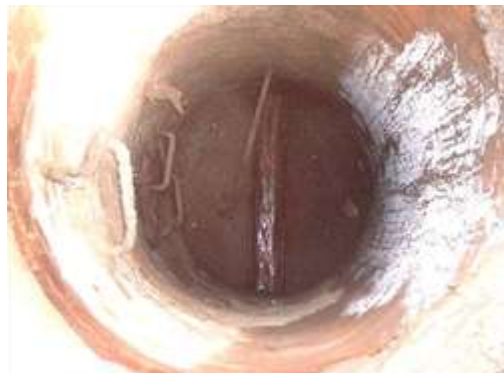
Top View

Corroded and missing steps. Bench debris.

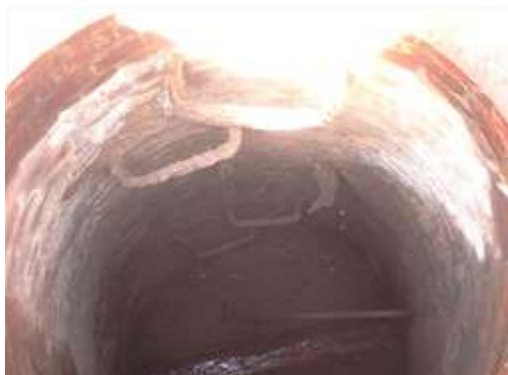
Defect

Barrel infiltration.

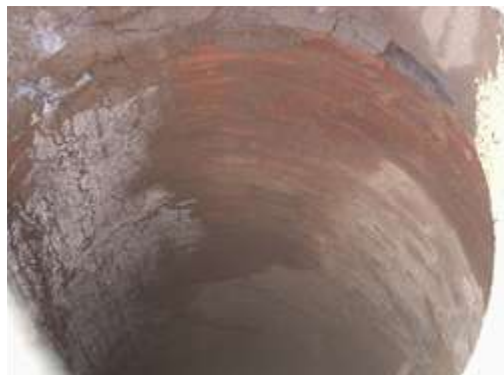
Defect

Frame leaks. Adjustment deterioration, loose brick and infiltration.

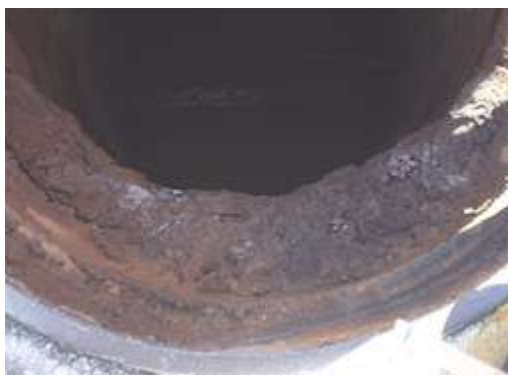
Defect

Frame leaks. Frame offset.

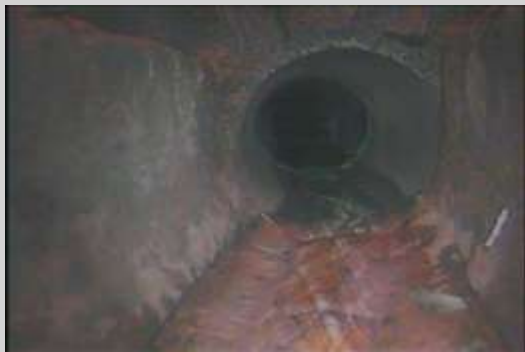
8 in. Circular Gravity Sewer Pipe Out @ 12 O'Clock

Infiltration: **None** Pipe Seal Cond: **Unknown**

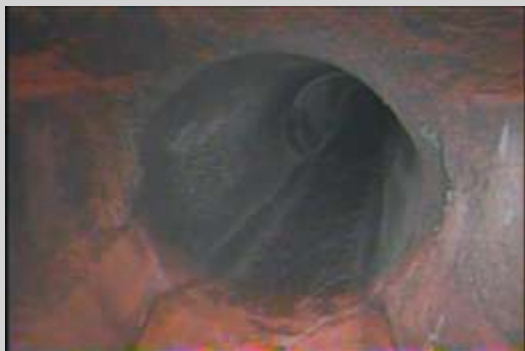
8 in. Circular Gravity Sewer Pipe In @ 6 O'Clock

Infiltration: **None** Pipe Seal Cond: **Unknown**
